St Oswald's Church Tower Project

Askrigg

September 2022

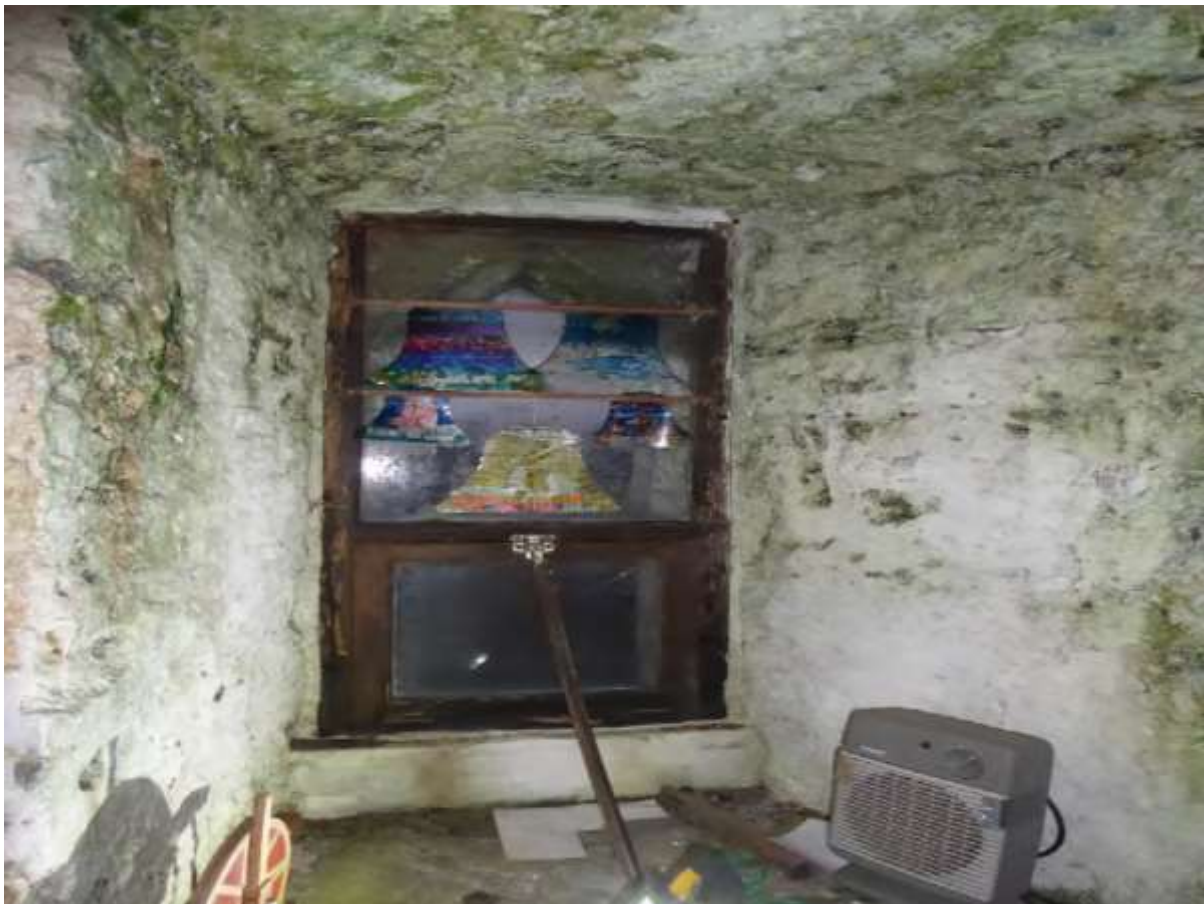
Inside the tower

The extreme dampness of the tower has led to the rotting of the bell ropes and the ringing chamber to be coated in green algae. The wood panelling has rotted, and conditions are not conducive to spending any time there.

Internal inspection of the tower confirms signs of significant water ingress into the wall core and interior surfaces. In the base of the tower, which is inside the church, the stone ribs of the vaulted ceiling have green algae staining and are noticeably damp and the adjoining plasterwork is also stained from above. The ringing chamber is similarly affected, and the panelling has been rotted by the damp. The floor timbers are a concern. The belfry is shows similar algae staining and damp walls. The internal woodwork including stairways will need to be reassessed due to the damp.

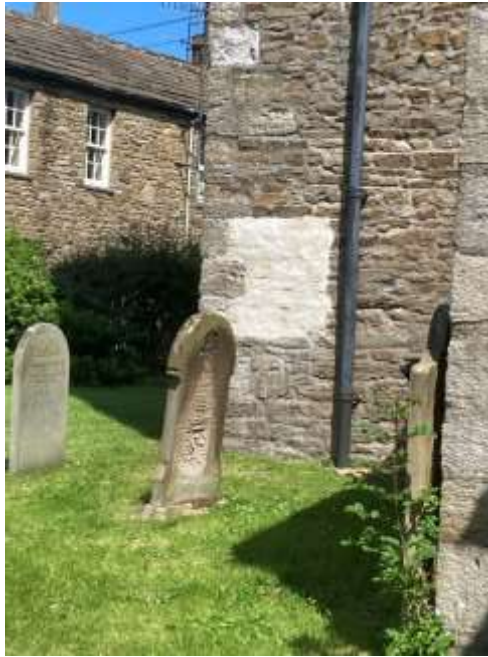
Test patches on south wall

It was found that removing all hard impervious cement-based pointing and render and the use of vapour/moisture permeable products in their place has produced the best outcomes. It was further found that pointing and rendering produced the most noticeable effects.

- to re-point the walls in feebly hydraulic lime mortar (NHL2) or lime putty mix which will be kept back from the general face of the elevation to provide a key for the render.

- Walls to be rendered using lime in an agreed mix incorporating either a non-hydraulic putty and/or as a hot mix which will include carefully sourced aggregates and sand to provide a base colour finish.

- The tower will then be limewashed over the whole surface
- The render will be applied in two layers to achieve a consistent minimum thickness. The final render will be finished to allow some of the aggregate to show. It will follow the natural contours of the elevations. Projecting stones may be left uncovered or just limewashed.
